# Water-filled Barrier Walls for Stormwater and Sediment Control on Steep Slopes

Chase Hemming, P.E.,<sup>1</sup> and Josef Tootle, P.E.<sup>2</sup>

<sup>1</sup>ENGEEO Incorporated; e-mail: [chemming@engeeo.com](mailto:chemming@engeeo.com)

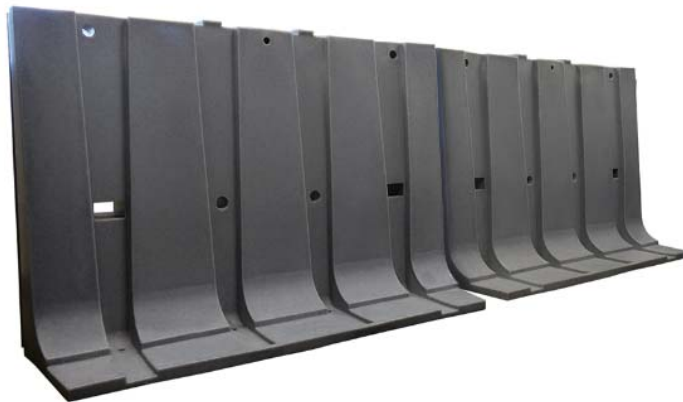
**Figure 1. Two interlocked barrier walls.**

A low density polyethylene (LDPE) barrier wall product called "Muscle Wall" was evaluated for its use in stormwater and sediment control on steep slopes. The barrier walls are approximately 4 feet in height, 6 feet in length, 2.5 feet in base width, 0.7 feet in top width, and 120 pounds in weight. The barrier walls are interlocked, secured to each other using ratchet tie down straps, filled with water, and wrapped with a plastic or geotextile liner to produce a linear barrier system. An image of two interlocked barrier walls without ratchet tie down straps or liner is shown in Figure 1.

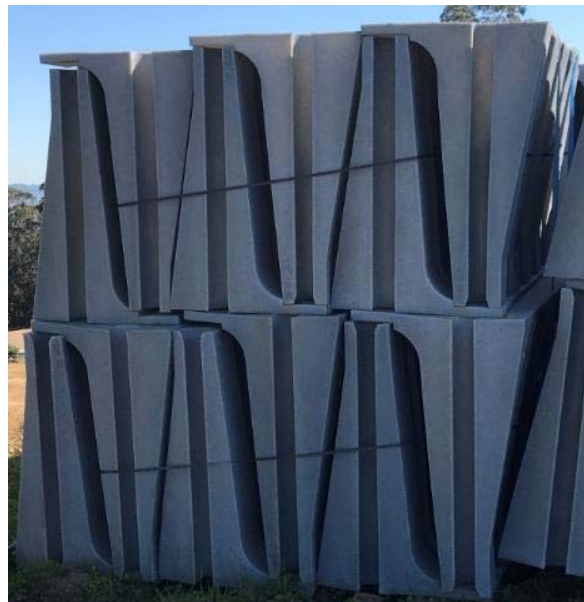
**Figure 2. Stacked barrier walls.**

Approximately 4,000 linear feet (LF) of the barrier wall product was ordered for the project site. The barrier walls, plastic liner, ratchet tie-down straps, and liner clips were shipped to the project site on seven truck trailers (approximately 95 barrier walls per truck trailer). Each pallet of the barrier wall product was observed to take up an approximately 8 feet by 6 feet footprint, and contained 12 barrier wall segments as shown in Figure 2. The barrier wall product pallets were removed from the truck trailer using a forklift and stored on the project site prior to deployment.

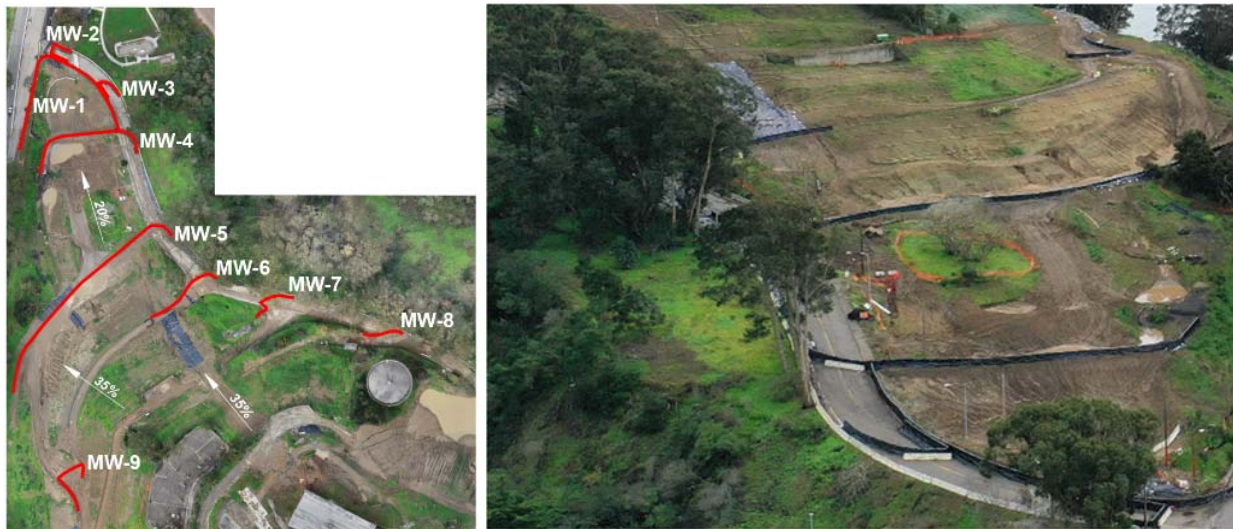
**Figure 3. Aerial view (left) and side view (right) of the barrier wall basin locations.**

The basins were designed to detain the runoff volume produced by a rainfall depth of 2 inches (approximately equal to that of a 10-year-recurrence-interval, 6-hour-duration storm). For storms forecasted to produce greater than 2 inches of rainfall, water trucks were staged at one of the downslope basins so that collected stormwater could be pumped and transported to a high capacity infiltration-evaporation basin in a flat region of the site. While expensive, the cost of the pumping and trucking operation was deemed cheaper than the cost of not completing the mass grading work on time. A series of nine temporary barrier wall basins with an average spacing of 150 feet were placed along the hillside, as shown in Figure 3.

Table 1 summarizes each barrier wall basin's length, cross slope (defined as the average slope perpendicular to the basin length), and surface placement type. Barrier walls that crossed active haul roads were not filled with water to allow for rapid removal during non-storm conditions. All barrier walls that were not located across an active haul road were filled completely with water to increase stability. In addition, all barrier walls were wrapped with plastic to limit seepage

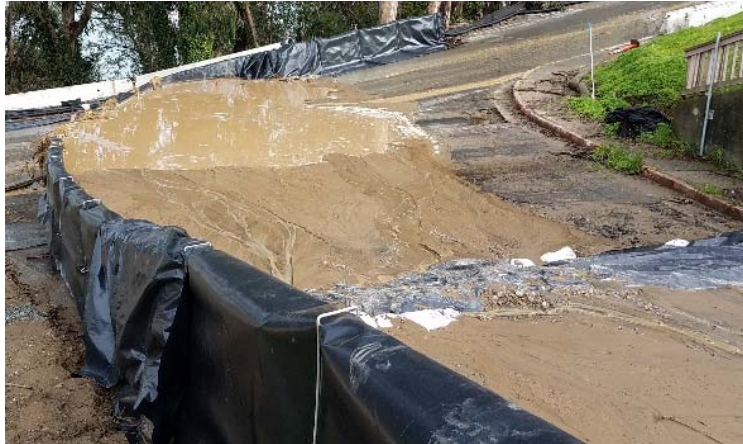
**Figure 10. Basin MW-6 retaining 4 feet of sediment following a storm.**

Basin MW-6 was located across an asphalt concrete haul road with a cross slope of approximately 15 percent. Unlike Basins MW-2 and MW-3, which made use of corner walls, Basin MW-6 had enough width across the haul road to form a semi-circular basin without using corner walls; the connection joints between barrier walls allowed for a deflection of approximately 11 degrees between each wall. Five barrier walls located across the haul road

were not filled with water. Like Basin MW-5, Basin MW-6 did not experience any lapses in stability while at capacity with stormwater and entrained sediment (Figure 10). Stormwater was observed to seep under the barrier walls during storm events; the turbidity of water leaving the basin appeared similar to that of water entering the basin.

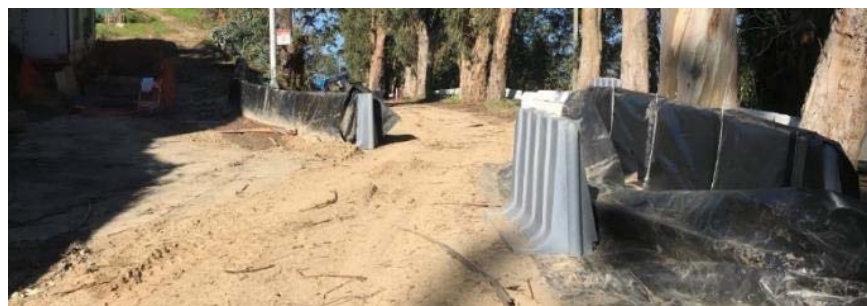
**Figure 11: Empty barrier walls set aside for haul road use.**

Basin MW-8 was located across a compacted soil haul road with a cross slope of approximately five percent. Like the other basins located across haul roads, five middle barrier walls were not filled with water. Figure 11 below depicts the empty barrier walls set aside during dry weather so that the haul road could be used. Because Basin MW-8 was the furthest upslope basin, it collected the least amount of stormwater runoff and never filled to capacity. However, it succeeded as a check dam for slowing water flow and detaining entrained sediment.

Leaving some barrier walls unfilled when located across an active haul road was convenient for the contractor’s site access; during non-storm conditions, the contractor would disconnect the unfilled barrier walls from the basin and set them aside to allow haul road use. If a storm event was forecasted, the contractor was able to quickly reconnect the unfilled barrier walls across the haul road.

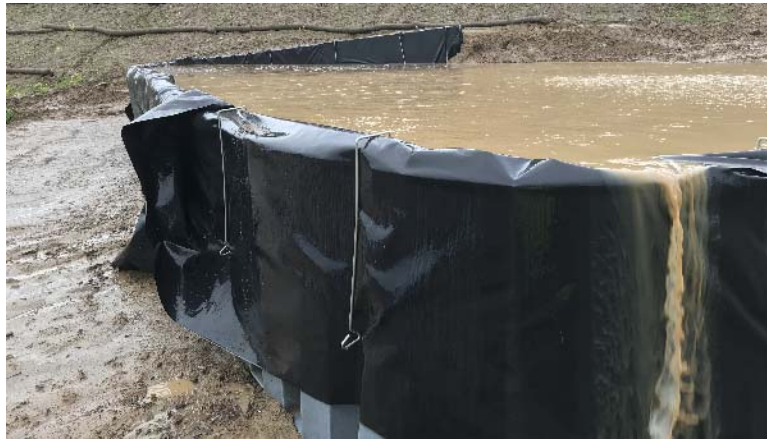
**Figure 12: Basin MW-9 overtopping during a storm event.**

Basin MW-9 was located across a compacted soil haul road with a cross slope of approximately 10 percent. Five barrier walls in the middle of the basin were not filled with water, and the basin utilized two corner walls to assist in forming the basin. Basin MW-9 often filled to capacity with water during storms, and accumulated sediment throughout the study period (Figure 12). Over the duration of the study period, Basin MW-9 did not experience any lapses in stability while at capacity with water and sediment. The turbidity of water leaving the basin through overtopping and seepage appeared similar to that of water entering the basin.

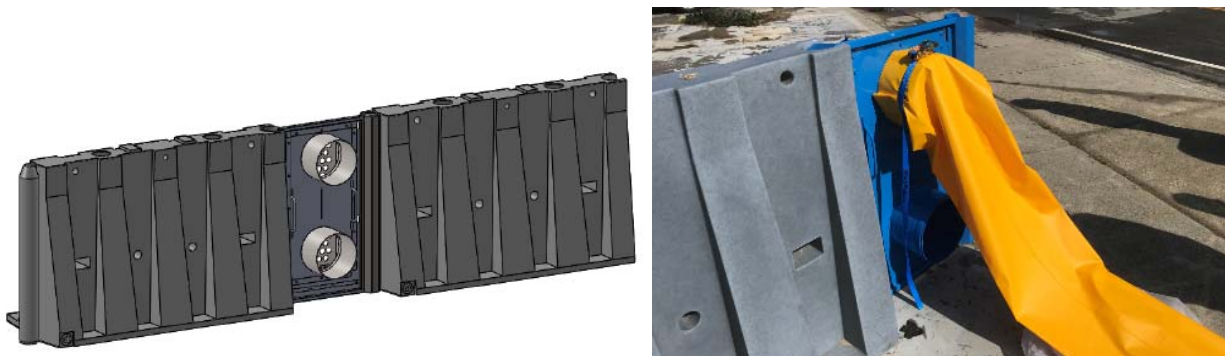
**Figure 13. Rendering of the discharge port (left) and photograph of the discharge port (right).**

To reduce seepage under the barrier walls, the plastic or geotextile liner could be trenched into the ground on the water side of the barrier wall (if placed on soil). For barrier walls placed on pavement, seepage under the barrier walls could be mitigated by placing sand bags tightly along the toe of the barrier walls. To reduce uncontrolled overtopping, the barrier wall product manufacturer developed a double-orifice discharge port during the end of the study period. A hose could be connected to the discharge port to route stormwater to an active treatment system or other water quality BMP to help reduce stormwater turbidity before offsite discharge. A rendering of the discharge port (left) and photo of the manufactured discharge port at the project site (right) are shown in Figure 13. The discharge port was not tested during the study period.
